Chewton Mendip 2012

Ongoing excavation update

Pip Osborne

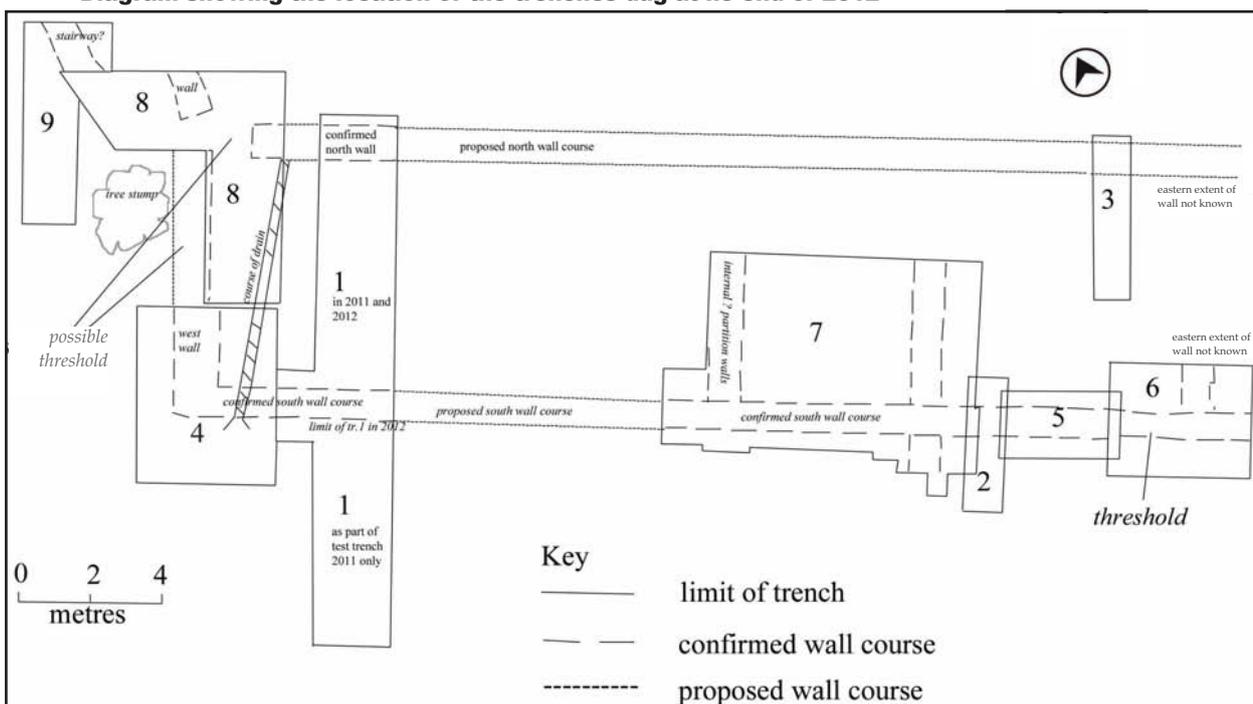
Figure 1
Diagram showing the location of the trenches dug at the end of 2012

Trench 7 was dug to locate the pipe and to see what possible damage to the archaeology it might have caused (see *Figure 1 for location*). We were relieved to find it had impacted very little on the archaeology, cutting a neat trench through the south wall and presumably the north wall too, though this has yet to be exposed in this area. This trench established that the building had two substantial internal walls at 90° to the south wall. A layer of rubble dump, an overall characteristic of this site, covered the internal floor surface, reinforcing the view that this building had been systematically robbed out and the ground levelled at some unknown date in the past. Within this trench and not encountered elsewhere, was a dark soil layer, and also evidence of heat damage within the stone coursing of the west face of the more easterly internal wall.

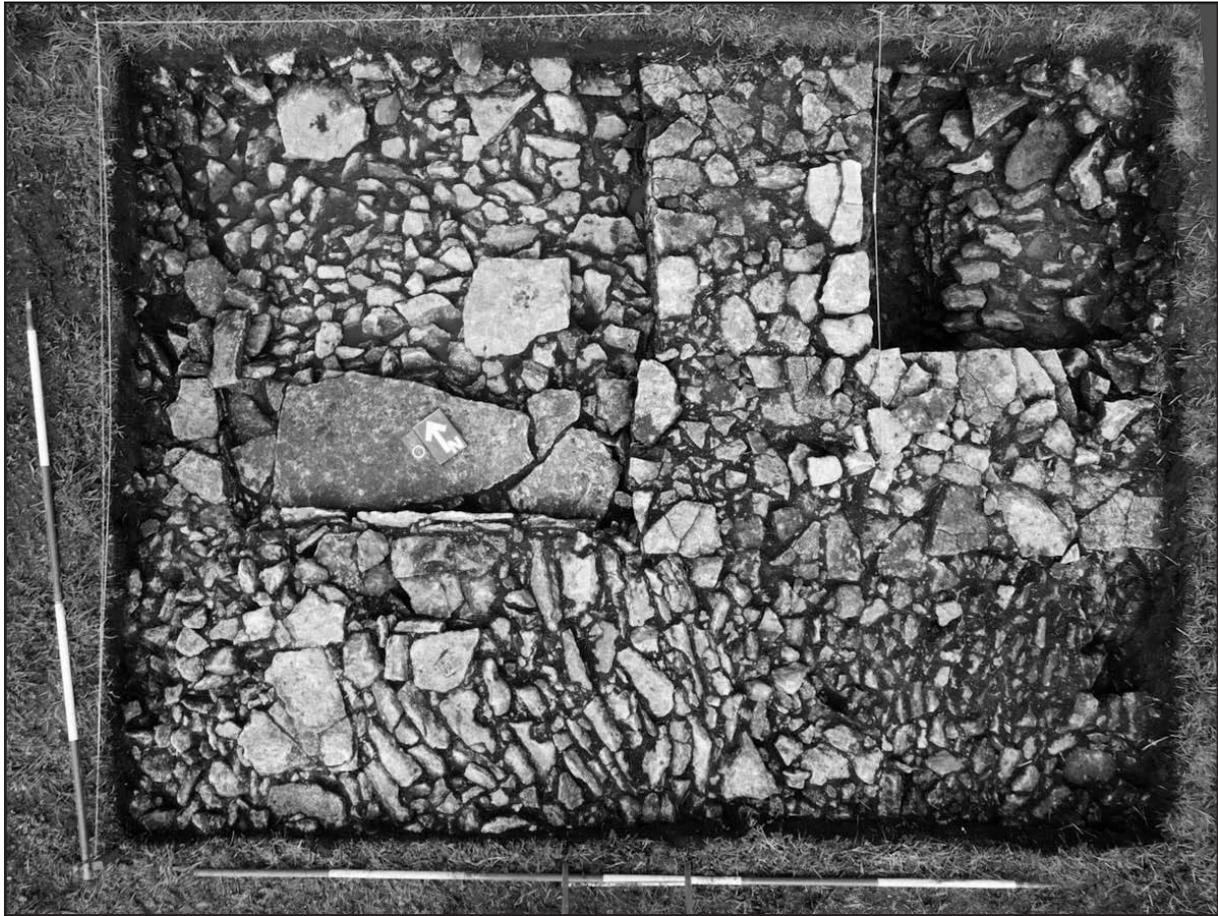
Figure 2 above
Aerial photo of
Trench 6 showing
threshold in south
wall with cobble
surface on either
side, and the beginnings
of a possible further
room to the east.
(J.Croxford)

Trench 6 was dug to the east of Trench 7, again following the south wall in the hopes of encountering the east gable end (see *Figure 2*). Whilst uncovering a threshold within the south wall and a fine cobbled entrance, we once again failed to find the end of the wall. This building is now at least 29 metres in length. Yet another wall running at 90° was found to the immediate east of the threshold, and appeared to be the southwest corner of yet another room. The internal threshold area was also covered in cobble, begging the question as to whether this might have been some kind of internal courtyard. In fact we now have to consider whether we may have a complex of buildings all butting up to one southern façade wall facing the church.

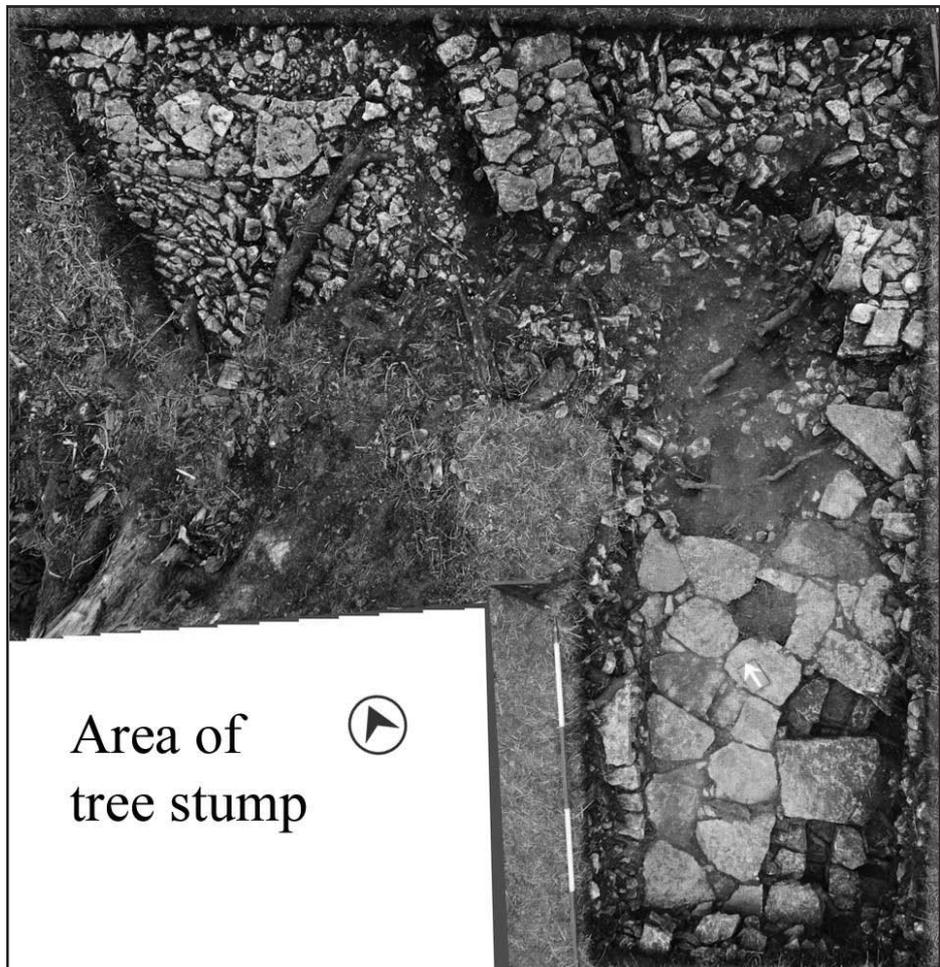
Figure 3
Trench 8 shows the
continuation of the
drain, the cobble
exterior ground
surface and additional
wall leading off from
the building's
northwest corner.
(J.Croxford)

In August the original test Trench 1 was reopened within the north and south walls and dug down to the natural in places. An additional Trench 8 (see Figure 3) was laid out parallel and to the west, with a metre baulk between trenches. This was in order to locate the continuation north of an underfloor drain, found last year in Trench 4, and also to catch the west gable end of the building. We were successful on both counts and also uncovered a curious oval, pitched, cobble floor surface, a feature of both the trenches. Its purpose remains a mystery. Lack of wall coursing in the west gable end suggests a further entrance, with exterior cobbling uncovered just beneath turf level on the northwest corner, mirroring that previously found to the southwest. A wall, thought to be of later date, was found to run from the northwest corner of the building at a different orientation. Unfortunately, the roots of a large sycamore tree stump have obliterated crucial archaeological evidence in this area.

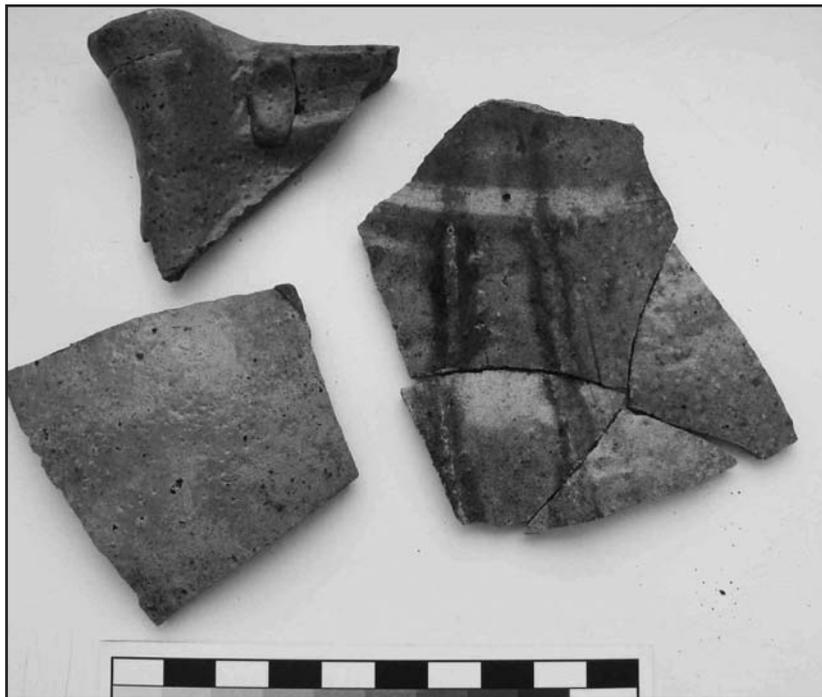
Figure 4
The sherds of medieval jug found in Trench 9, now confirmed as 13th Century Bristol ware. Black/white scale 10cm.
